BEAVER BROOK, MORRIS COUNTY

SPLIT ROCK POND DAM

PHASE I INSPECTION REPORT NATIONAL DAM SAFETY PROGRAM

NJ 00264

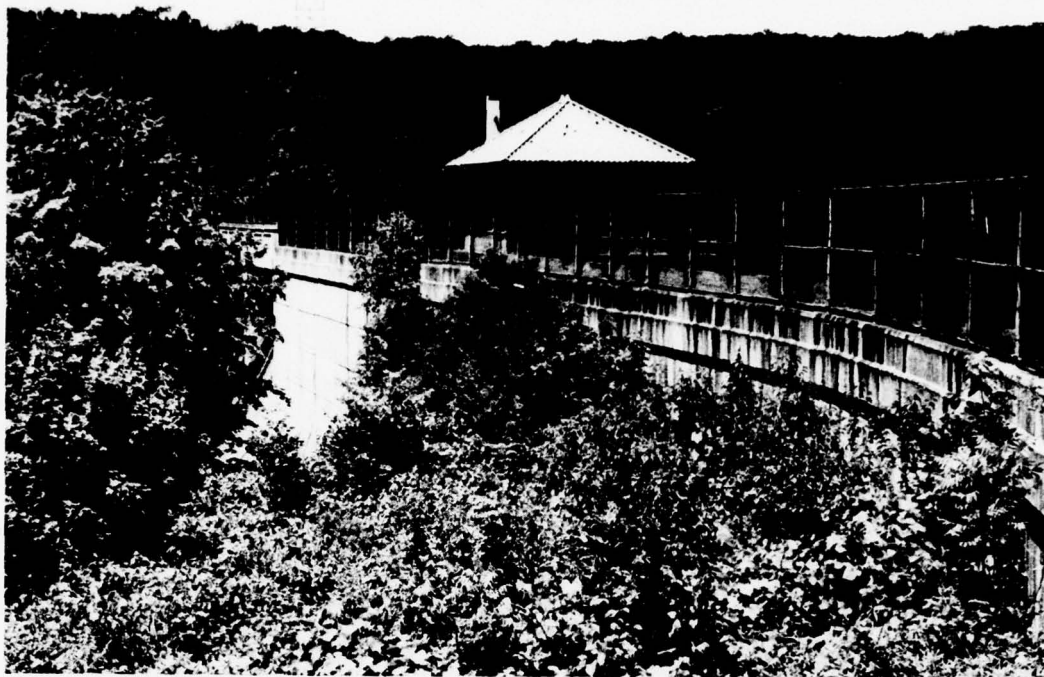
PHOTO 1

Photo 1 - View West Along Downstream Face of Dam From Left (East) Abutment - Gate Chamber in Center of Photo; Spillway Behind Trees in Left Side of Photo - 15 June 1978.

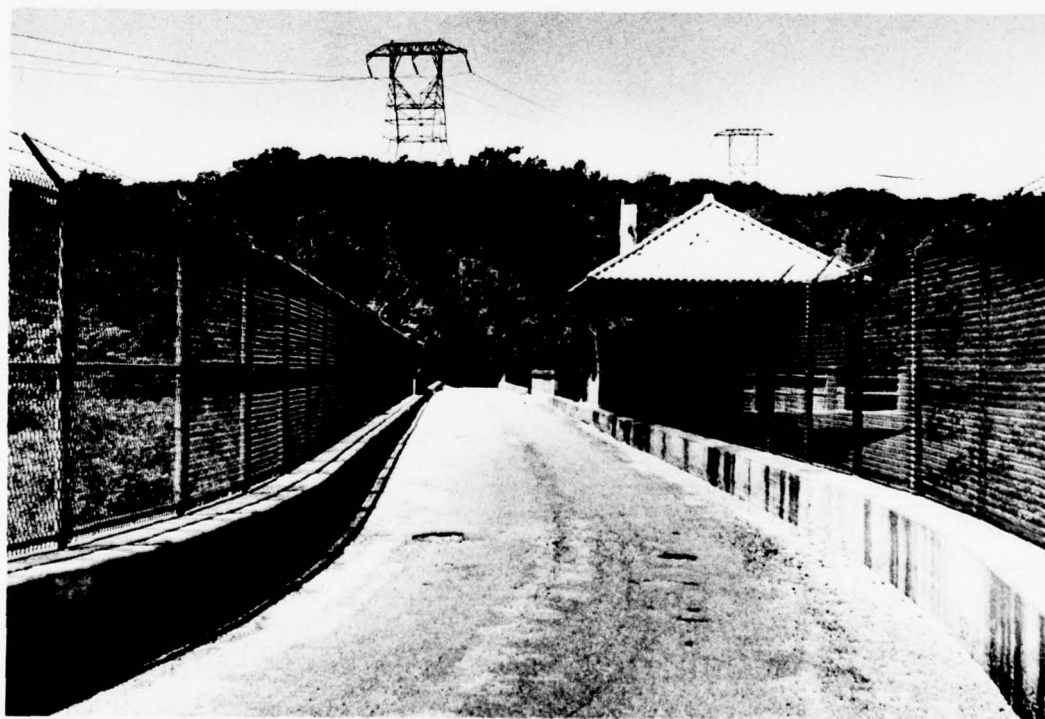
PHOTO 2

Photo 2 - View West Along Road Over Crest of Dam From Left (East) Abutment - Gate Chamber in Right Center of Photo - 15 June 1978.

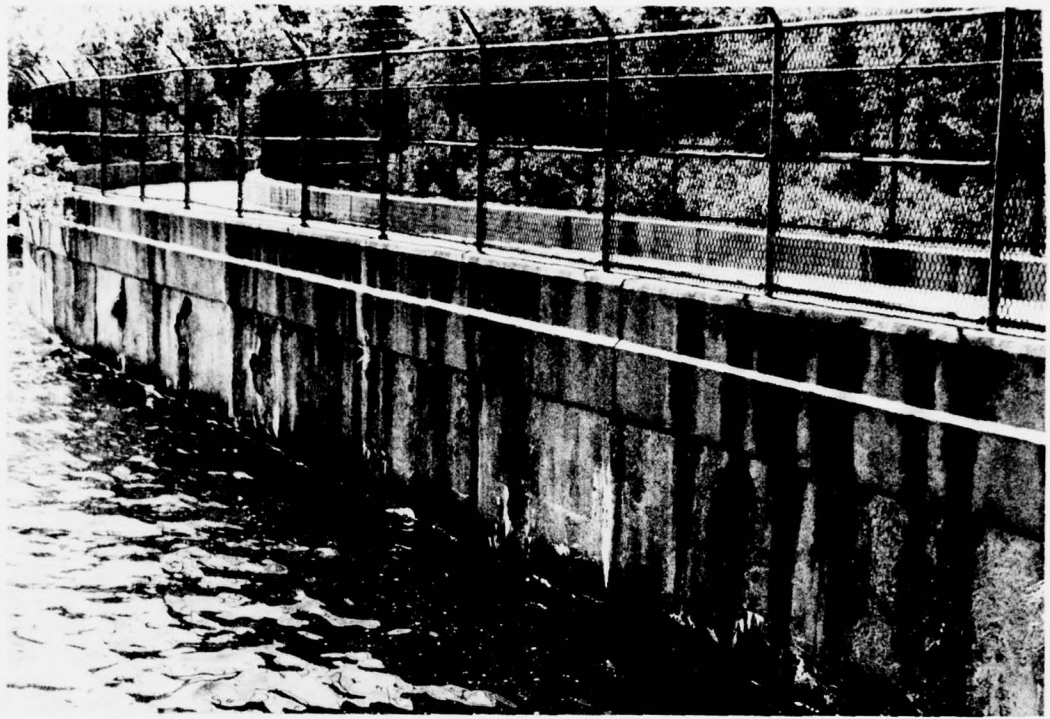
PHOTO 3

Photo 3 - View Downstream (Southeast) at Left (East) Side of Upstream Face of Dam From Gate Chamber Walkway - Small Trees in Weep Holes of Road Fill Retaining Wall in Top Left Corner of Photo - 16 June 1978.

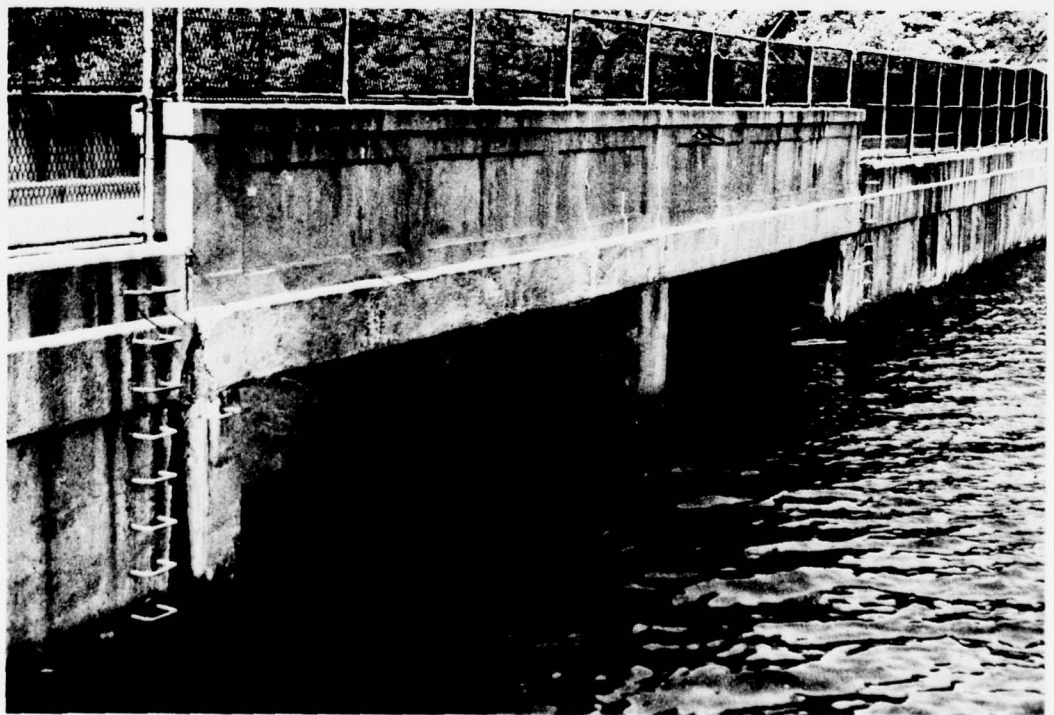
PHOTO 4

Photo 4 - View Downstream (Southwest) at Right (West) Side of Upstream Face of Dam From Gate Chamber Walkway - Spillway in Center of Photo - 16 June 1978.

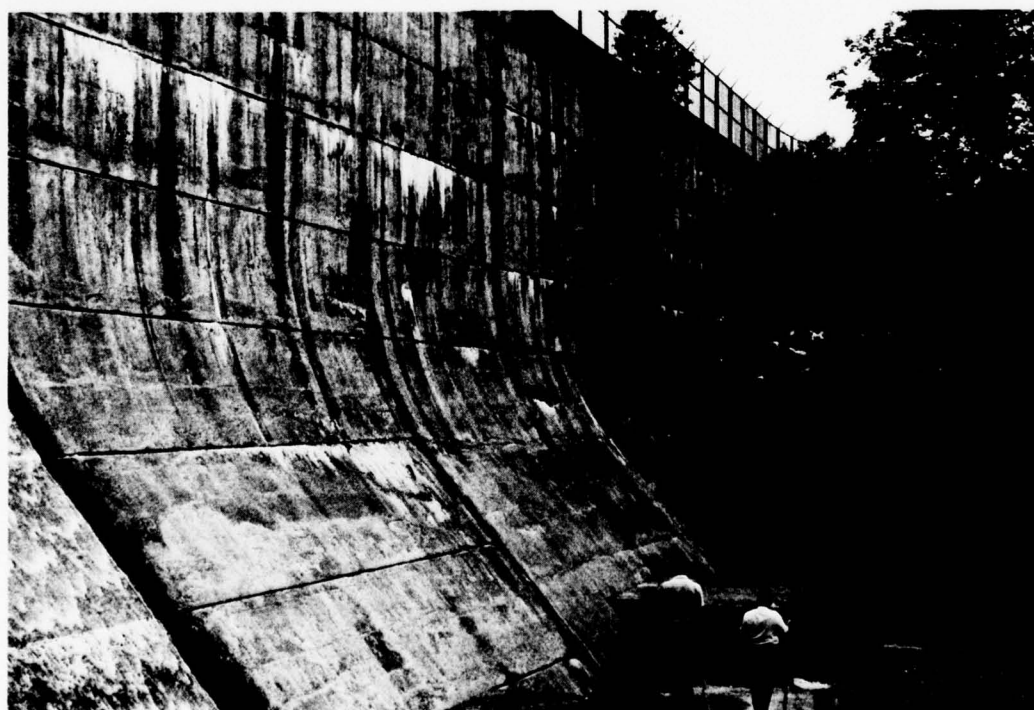
PHOTO 6

Photo 6 - View Northeast Across Downstream Face of Dam From Right (West) Abutment - Spillway in Bottom Left Corner of Photo; 36 Inch Diameter Outlet Pipe in Bottom Center of Photo Behind Two Men; Six Inch Diameter Tree Growing From Retaining Wall Weep Hole in Top Center of Photo - 16 June 1978.

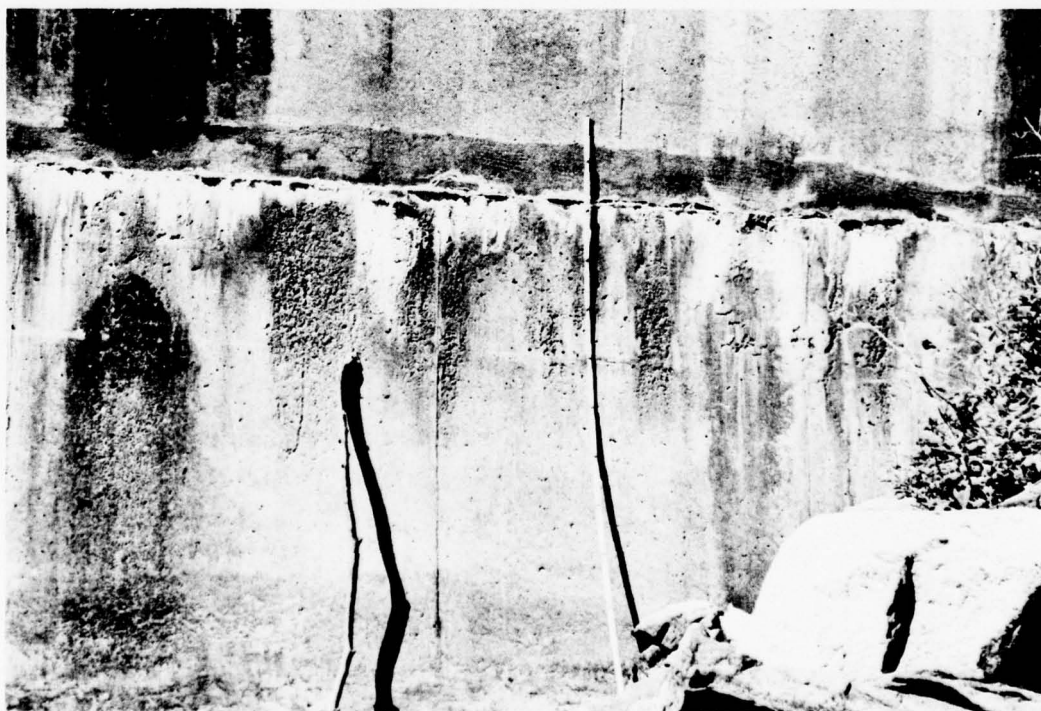
PHOTO 8

Further, the seepage from the abutment rock near the junctions with the downstream face of the dam is not considered detrimental to dam stability at the present time. The abutment seepage areas should be visually monitored in the future by the owner's personnel or others who make future inspections of the dam.

Photo 8 - Close-up of Concrete at Approximately El. 830 on Left (East) Side of Downstream Face of Dam - Seepage and Mineral Deposits Along Horizontal Joint; Six Feet Rule for Scale - 15 June 1978.

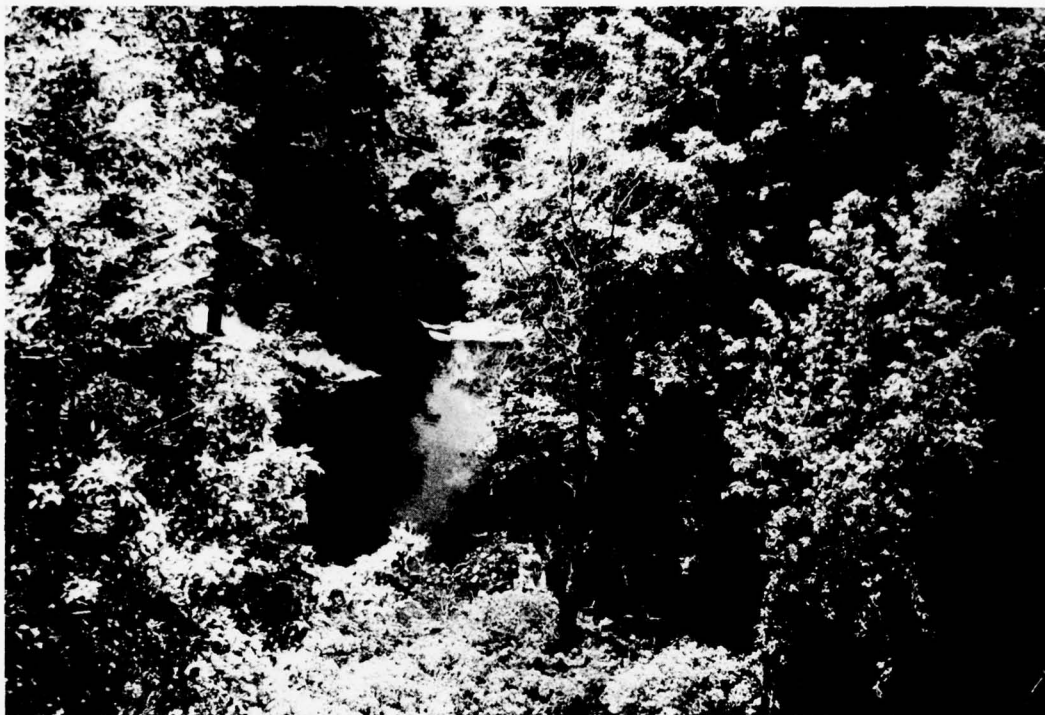
PHOTO 9

Photo 9 - View Downstream (South) Over Outlet Channel From Dam Crest Above Outlet Pipe - Concrete Weir (Close-Up in Photo 10) Is at White Water Area in Top Center of Photo - 15 June 1978.
